LAKE LENAPE DAM

NJ 00450

PHASE 1 INSPECTION REPORT
NATIONAL DAM SAFETY PROGRAM

February, 1979

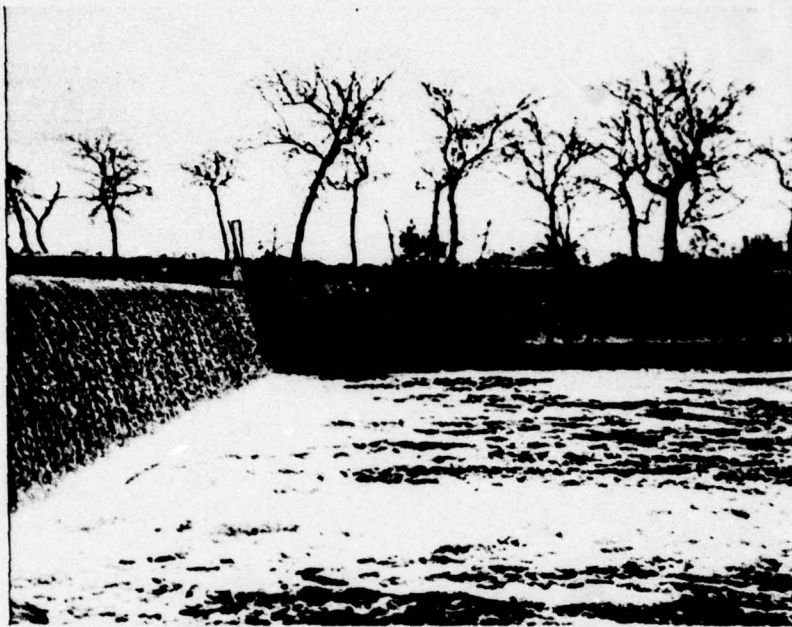
The embankment east of the spillway, although it was also brought up to grade during the 1977 repair work, has a ill-defined rather steep backslope which is devoid of stabilizing ground cover or slope protection. There are numerous secondary-growth trees along the slopes and several low spots on the top of embankment near the left abutment where traffic depressions exist in the dirt road on the crest. Considerable seepage was observed along the downstream toe. The upstream face is partially protected from wave action by several large pieces of broken concrete riprap. The lake front has silted up along the upstream shore so that the water appears to be only a few feet deep along the front of the dam.

View of spillway and East embankment

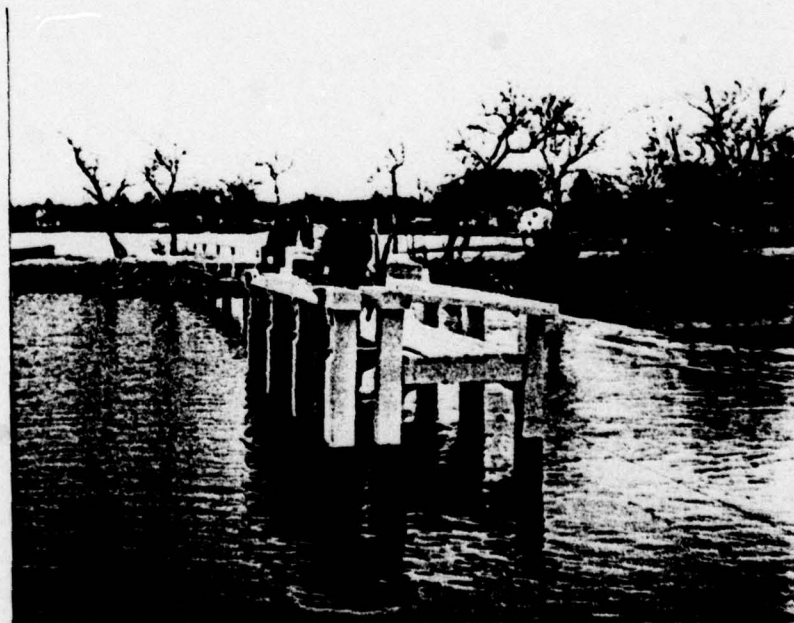
During the inspection, the spillway crest appeared in reasonable condition; however the main points of interest are the three 48" sluice gates. These are in good working order and are in use most of the time. At low heads over the crest, these sluices provide the bulk of the spillways capacity. However, due to the high exit velocities there is likely to be scour just below the downstream apron. This could not be verified due to the depth of water but substantial outlet velocities were observed.

Operating controls for 3-48" \varnothing RCP

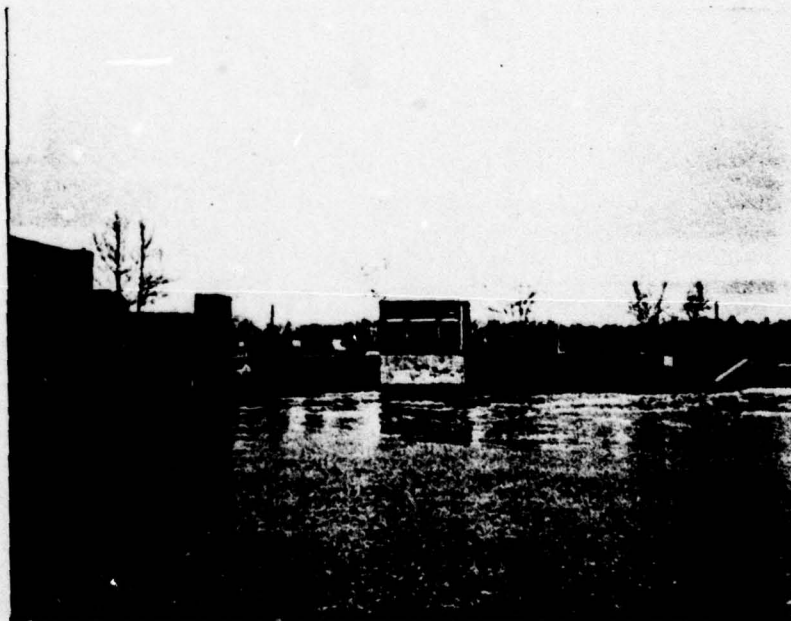
Powerhouse and West embankment from bridge

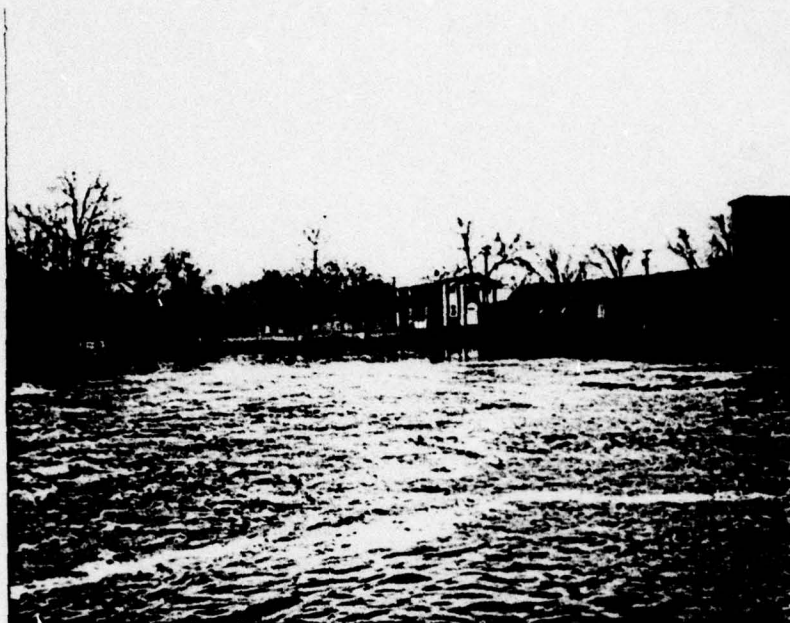
Highway bridge 500' downstream from spillway

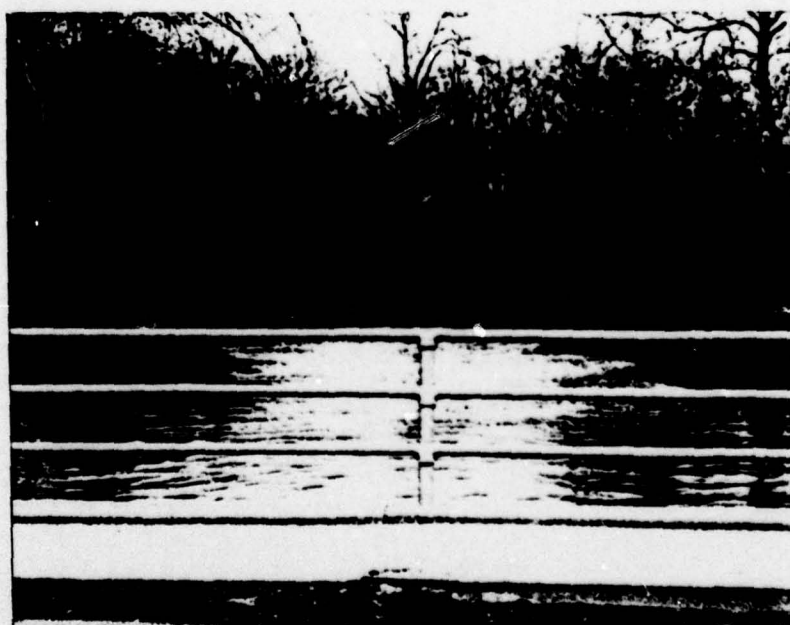
View of downstream channel from highway bridge

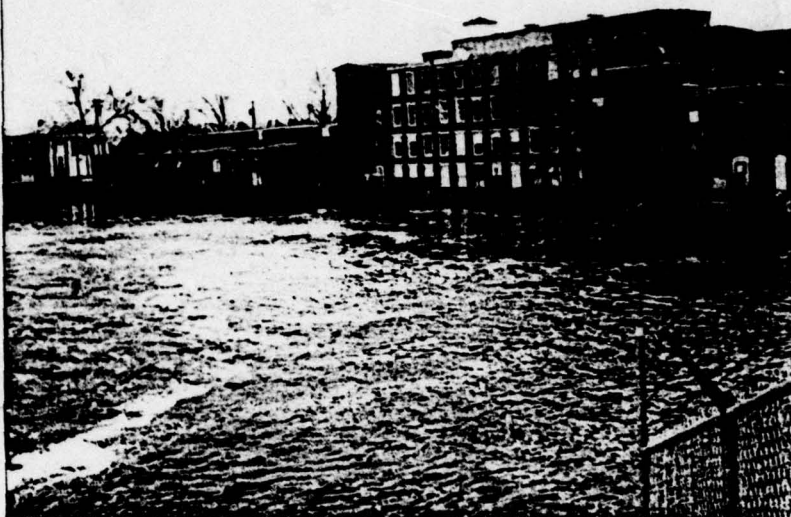
Wheaton Plastics buildings below spillway

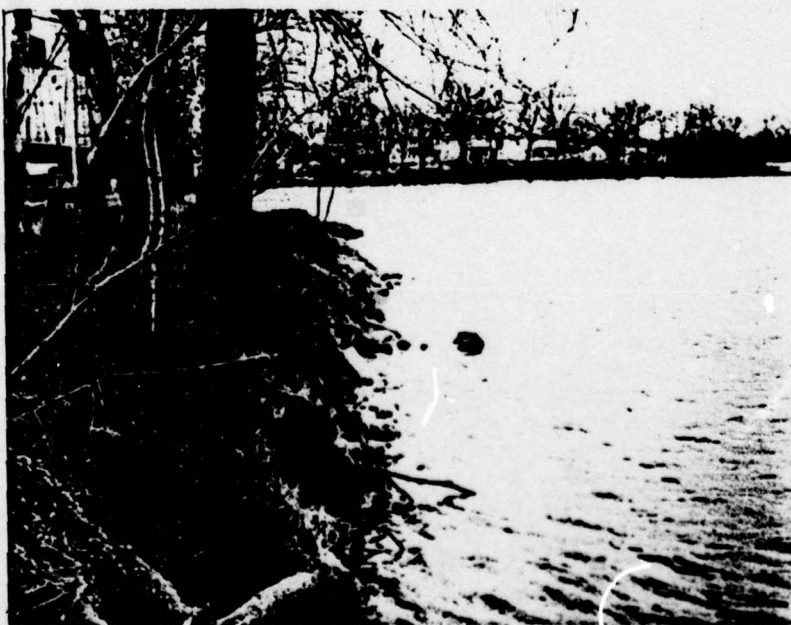
Lakeside embankment right of spillway

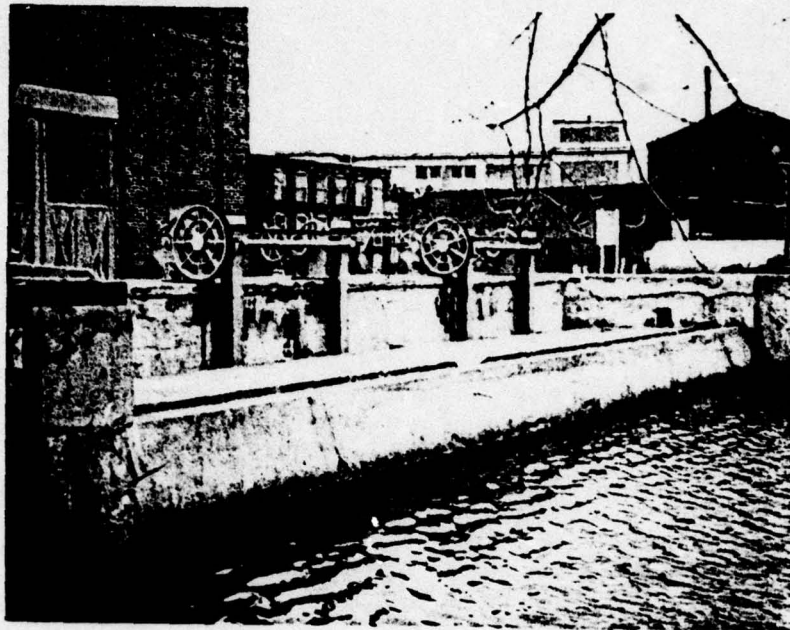
The concrete intake structure to the powerhouse and ice chute are spalled at the waterline and exhibit minor cracking. The vertical lift sluices are in good condition, having been recently overhauled. However, the capacity of the two 24-inch discharge pipes and the ice chute are negligible insofar as the overall dam hydraulics are concerned. The crest of the ice chute is presently maintained with timber lagging. The concrete sidewalls are in fair condition, having been built integrally with the east foundation wall of the powerhouse.

Vertical lift gates for 2-24" \varnothing pipes to powerhouse

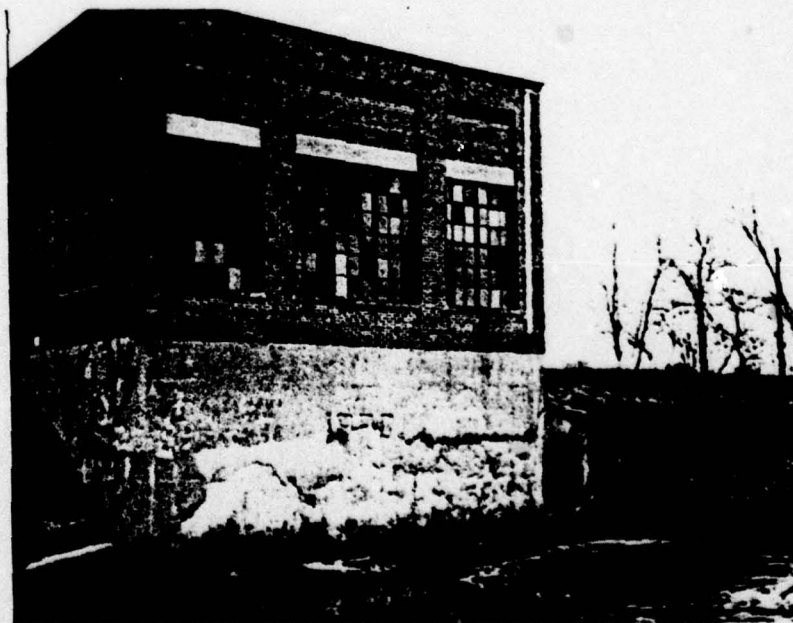
Old powerhouse with ice gate discharge at right
